Effects of Waterlogging on the Performance of Ruvu to Mlandizi Road Pavement

Waterlogging is a problem on the road embankment constructed from Ruvu to Mlandizi. During the rainy season, the rainwater and floods from the Ruvu River cause the water table to rise, and the water tends to infiltrate the embankment. This scenario has led to severe defects on the road pavement, such as potholes, alligator cracks, heaves and ruts, regardless of frequent maintenance conducted. This paper establishes a methodological approach aimed at assessing failures of Ruvu-Mlandizi road pavement sections. A levelling survey was conducted to establish the topographical nature of the road section. The determined levels were compared with specified requirements of road design against actual embankment heights. The results indicate that there was a need to raise the embankment to appropriate heights to accommodate flood levels and overcome water overtopping the road. The excavation of two trial pits to determine the actual depth of the water table on a road section was also conducted. Results reveal that the water table was at a depth of 0.3 m from the top of the improved subgrade surface. Based on the stu

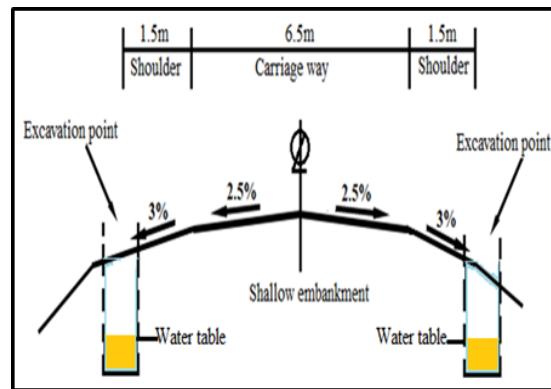
Figure 2
The Road Section Indicating Position Prepared for Trial Pits Excavation

The embankment materials were excavated from trial pits with a depth of 1 m from the edge of pavement shoulders on both sides of the carriageway (Figure 2). The existing embankment materials excavated were identified as G7 reddish gravel and the upper layer G15, grey-coloured gravel. The soil laboratory testing results on properties and characteristics of existing embankment materials are as shown in Table 1.

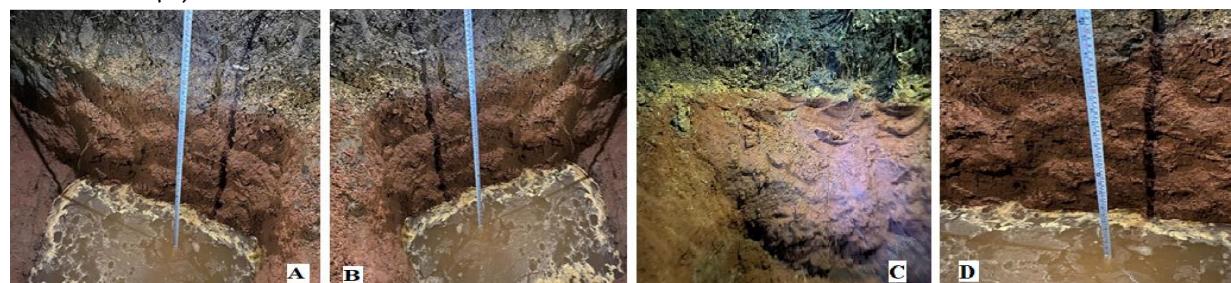
Figure 3

The trial pits were excavated at Ch 2+075km, 2+475km, 2+875km and 3+075km. The excavated trial pits indicated a water table at 0.3 m to 0.5 m below the improved fill material G7, as illustrated in Figure 3. The water table causes a weakness of the embankment foundation and causes defects to the pavement layers. The

(2000). There is a need for raising the embankment to meet the specified road design requirements. The levels of embankment noted were very low compared to the nature of the land (Punmia, 2011). The depth of the water table found in each trial pit was measured with reference to the road shoulder edge as indicated in Table 2 and Figure 3. The requirement of water table depth below the improved subgrade is 1.5 m (IRC:34-2011).

S/No	Location (km)	Depth of water Table below shoulder edge(m)
1	2+075,	0.85
2	2+475	0.8
3	2+875	1
4	3+075	0.8

Excavated Trial Pit of Existing Road at Ch 2+075.km (A), Ch 2+475 (B), Ch2+875km(C) and Ch3+075km(D)

materials. It is recommended that the responsible authority have to review the design and implement it (RGDM, 2011). In this regard, the requirements of embankment height shall be a minimum of 1.5 m height above high flood level (HFL) (IRC:34-2011). However, in case the method of raising the height of the embankment is difficult and cost-intensive, then the method to lower the water table may be applied. It could be conducted by the use of a subsurface drainage system or other similar systems. The embankment height of trunk roads shall not be less than 1.2 m from the low land level as

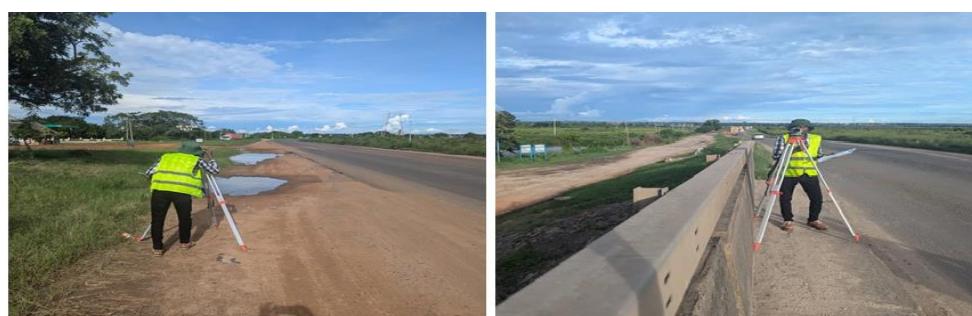
Figure 4

Taking Levels along the Existing Road at Ch 3+500km and Ch 6+350km

The exercise of taking levels was conducted along the road section of 6.35 km. The results of existing embankment heights are indicated in Table 3. A table defines the available height of the embankment of the entire road. The heights of the embankment are defining the current situation of road levels. The minimum height of the embankment is 0.337 m, the maximum height of the embankment is 1.954 m, and the average height of the embankment is 1.01925 m. Those above results indicate that the existing height of the embankment is below the requirement of 1.5 m (IRC:34-2011). Therefore, in order to safeguard the life of the pavement, it is necessary to raise the embankment, especially during the high flood. The design requirement for embankment height is to reduce the effect of floods on the road. High

Due to the levels taken on the entire road section, it was found that a maximum high flood river level was determined at the least low-level edge of the road by a reduced level of 50.544 m at Ch 5+025 km. This is due to the information provided by the Road Authority regarding the rainy season of the year 2023/2024. The current maximum river level found during the levelling exercise was 49.426 m. The river flow height gauges were not seen due to the increment of depth of the river. This suggests that the height of the embankment should be raised to accommodate high flood levels by 1.5 m above the existing pavement surface.

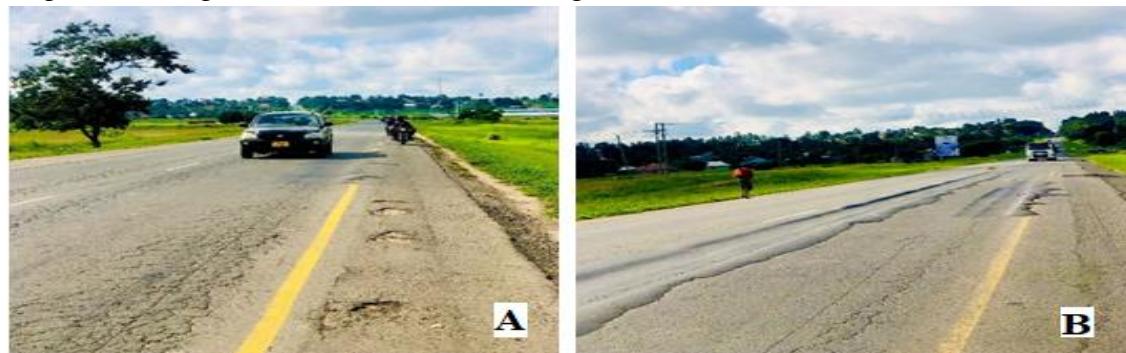
Figure 6

Alligator Cracking at (Ch1+200km) (A) and rutting at (Ch 1+500km) (B)

The pavement condition index (PCI) is a method for measuring pavement defects. The measured defect quantities and determined percentage damages for each defect type are indicated in Table 4. The road surface distress affects ride quality, structural integrity and skid resistance. The measurements and analysis of road distresses and determination of pavement condition index (PCI) were conducted following the procedures stipulated in ASTM D 6433-11. The study identified different types of defects on the road surface. The major defects found on the road surface are potholes, cracking, ruts, corrugation and heaves (Figure 6).
