Effects of Waterlogging on the Performance of Ruvu to Mlandizi Road Pavement

Waterlogging is a problem on the road embankment constructed from Ruvu to Mlandizi. During the rainy season, the rainwater and floods from the Ruvu River cause the water table to rise, and the water tends to infiltrate the embankment. This scenario has led to severe defects on the road pavement, such as potholes, alligator cracks, heaves and ruts, regardless of frequent maintenance conducted. This paper establishes a methodological approach aimed at assessing failures of Ruvu-Mlandizi road pavement sections. A levelling survey was conducted to establish the topographical nature of the road section. The determined levels were compared with specified requirements of road design against actual embankment heights. The results indicate that there was a need to raise the embankment to appropriate heights to accommodate flood levels and overcome water overtopping the road. The excavation of two trial pits to determine the actual depth of the water table on a road section was also conducted. Results reveal that the water table was at a depth of 0.3 m from the top of the improved subgrade surface. Based on the stu

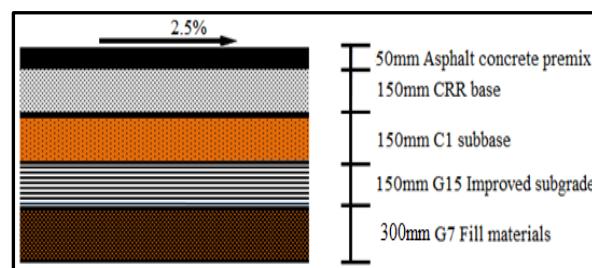
Figure 1
A Detailed Existing Road Section Pavement Layer

Pavement materials of the entire road section comprise layers as illustrated in Figure 1.

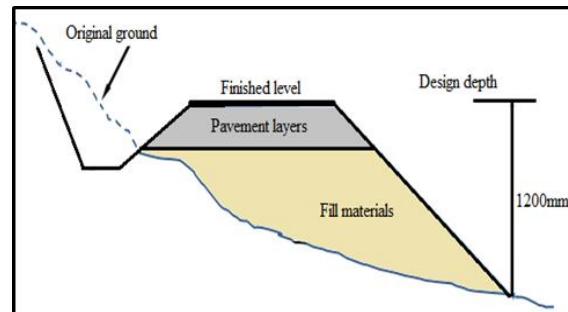
Figure 5
 Pavement Design Depth of Paved Trunk and Other Road

materials. It is recommended that the responsible authority have to review the design and implement it (RGDM, 2011). In this regard, the requirements of embankment height shall be a minimum of 1.5 m height above high flood level (HFL) (IRC:34-2011). However, in case the method of raising the height of the embankment is difficult and cost-intensive, then the method to lower the water table may be applied. It could be conducted by the use of a subsurface drainage system or other similar systems. The embankment height of trunk roads shall not be less than 1.2 m from the low land level as

indicated on Figure 5 (PMDM, 1999). Other studies suggest that the water table should be maintained at a depth not less than 1.2 m below the road formation level (RGDM, 2011).
